DAM REMOVAL CONCEPTUAL PLAN

Golden Lotus – Song of the Morning
Lansing Club Pond Dam

May 2010

Project No. 09388639

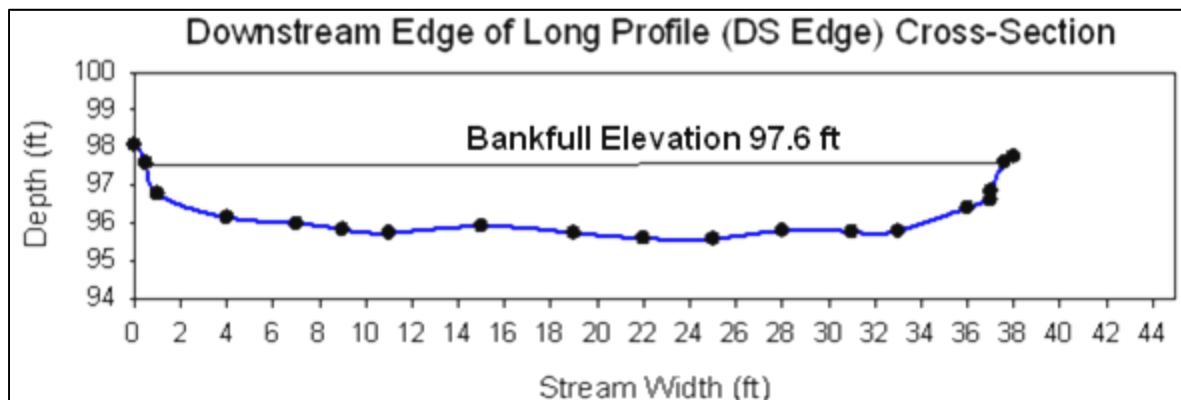
The downstream reference reach (see Figure 3) was chosen as the reference cross section to assess hydraulics and sediment transport capacity under bankfull discharge conditions. Elevations are given as relative elevations. The bankfull elevation for the cross section was estimated during the survey of the cross section at 97.6 ft. Flow area under bankfull discharge conditions is approximately 62 ft².

The hydraulics (e.g. flow velocity, depth, bed shear stress) under bankfull discharge conditions are calculated for the reference cross section using the bankfull elevation provided with the cross section survey and average bed slope of 13 feet per river mile. Hydraulic calculations are done using Bentley FlowMaster® V8i software using the standard Manning formula.

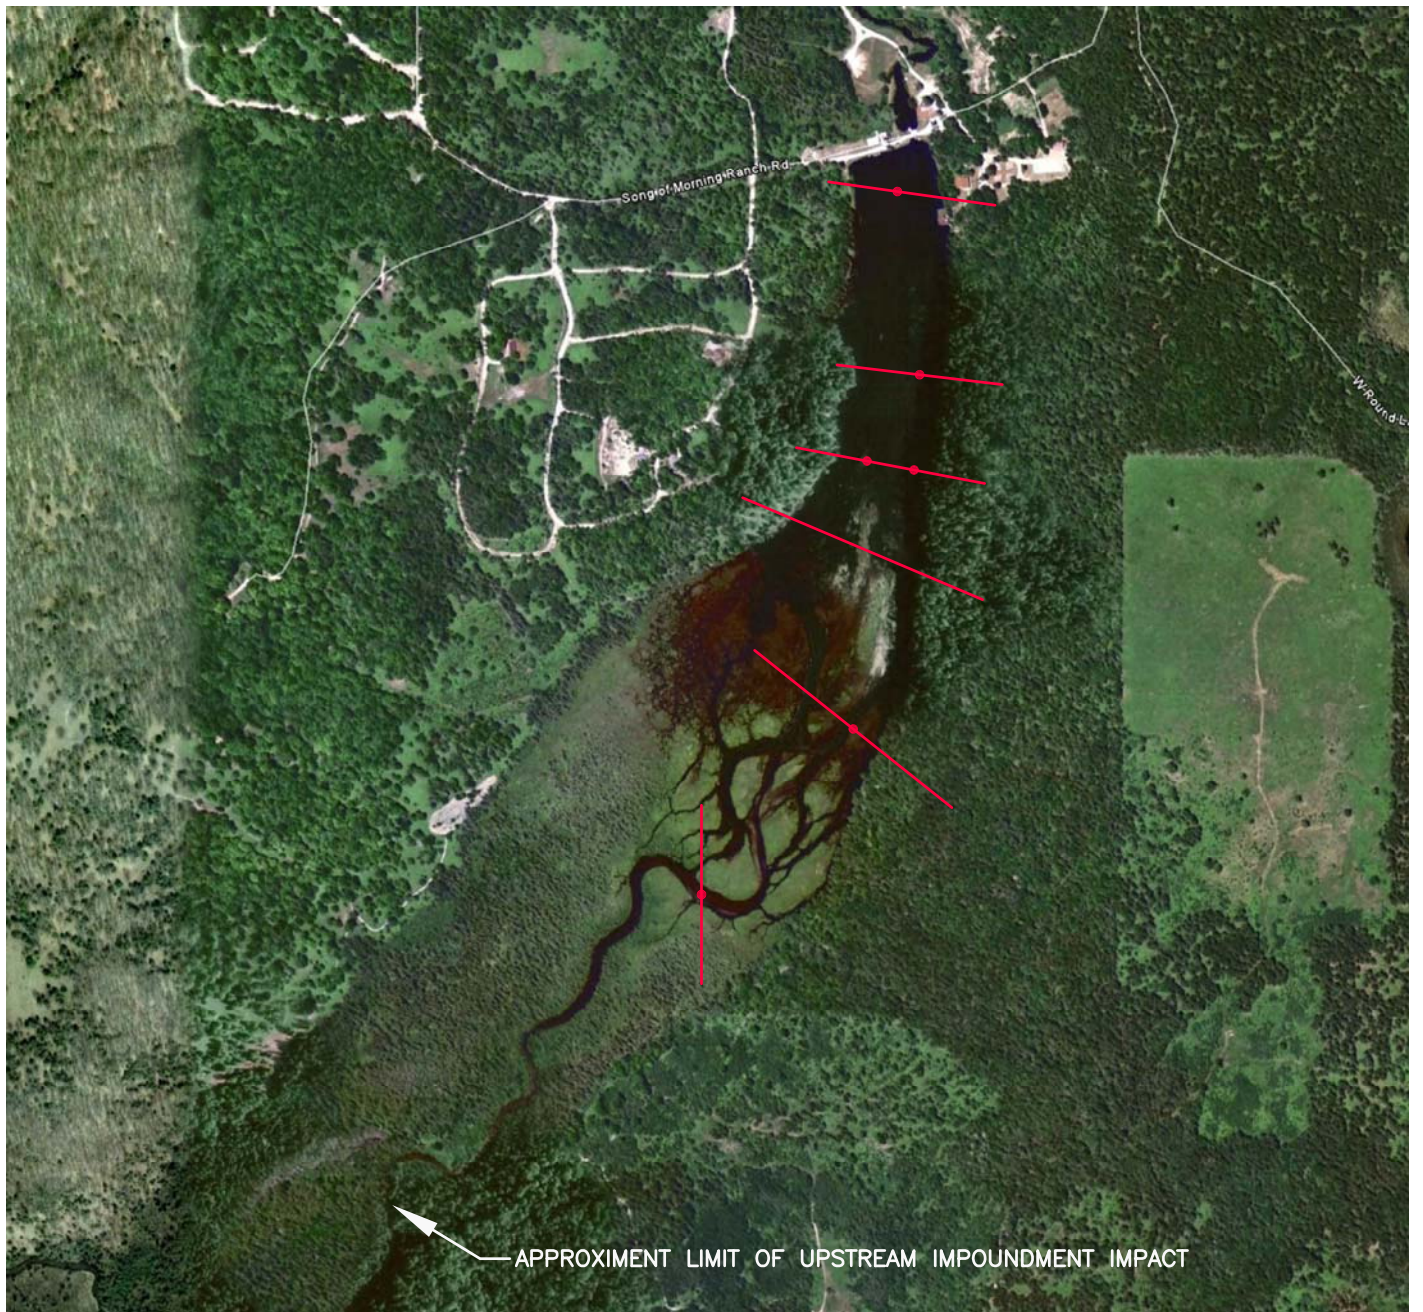
SCALE	AS SHOWN	TITLE	SEDIMENT SAMPLING LOCATION MAP SONG OF THE MORNING
	DATE	04/23/10		
FILE No.	09388639A003	DESIGN	TS	CONCEPTUAL DAM REMOVAL PLAN
PROJECT No.	093-88639	CADD	MGG	
REV.	0	CHECK	MRF	
		REVIEW	TAS	FIGURE 2

- PROPOSED SEDIMENT QUALITY SAMPLING LOCATION (APPROXIMATE)
- PROPOSED SEDIMENT CORE TRANSECT LOCATIONS (APPROXIMATE)

Pursuant to the Interim Order, Golden Lotus proposes to collect six (6) sediment core samples from the existing impoundment area for subsequent laboratory analysis of PCBs, PNAs, and M-12 metals. Golden Lotus also proposes to collect additional core samples along established transects for subsequent physical characterization of sediment composition. It is proposed to perform the physical characterization at 6-inch intervals vertically along the cores. Along established transects, 2-3 cores (in addition to the cores being collected for laboratory chemical analysis) will be characterized and preserved. Cores will be collected via manually pushing a sediment coring device until refusal. Proposed sediment sampling locations for laboratory chemical analysis and transect locations for physical characterization are shown in Figure 2.

Sediment Quality - Four (4) core locations are proposed within the impoundment area where sediments are expected to be dominated by organic debris and silts. Two (2) additional locations are located in the Pigeon River main channel and braided channel areas where sediments consist of sand overlain by organic debris and silts, but in areas where sediment transport is expected due to re-establishment of a stable reach.

Sediment Composition – Six (6) sediment composition transects are located within the impoundment area and upstream of the impoundment area. Five (5) of the transects include locations where sediment core sampling and laboratory chemical analysis is proposed.

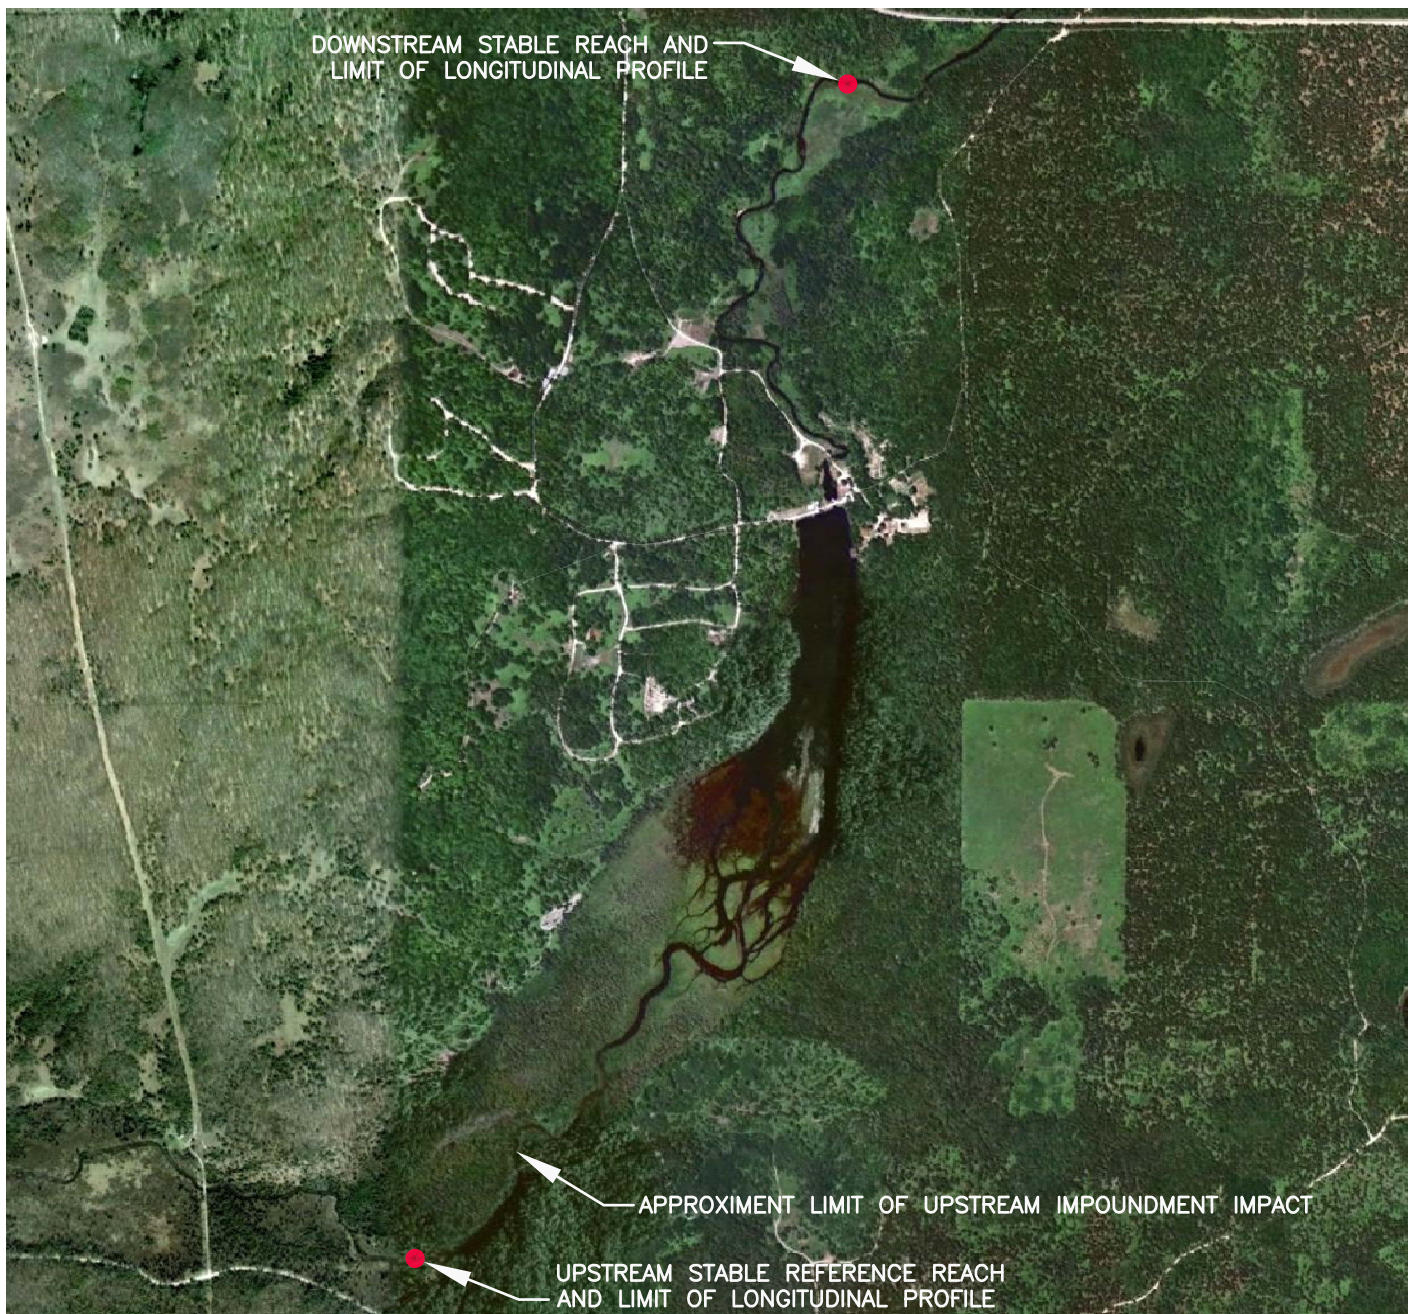
TITLE
REFERENCE REACH LOCATION
 SONG OF THE MORNING

- UPSTREAM / DOWNSTREAM LIMITS OF LONGITUDINAL PROFILE

Upstream Reference Reach - Based on preliminary reconnaissance of the Pigeon River upstream of the impoundment, a stable reference reach was identified approximately 1.5 miles upstream of the dam (see Figure 3). The Pigeon River in the vicinity of this location is characterized by a series of run/riffles and occasional moderately defined pools. The identified reference reach location is positioned in a run/riffle within a relatively straight section of the Pigeon River. Substrate in this section of the Pigeon River (including the identified reference reach location) is comprised of gravel and sand with occasionally some organic debris and silt on the channel margins. The identified stable upstream reference reach will serve as the upstream limit of the longitudinal profile and as one of the 6 - 12 cross-sections to be established and surveyed.

Downstream Reference Reach - Approximately, $\frac{3}{4}$ mile downstream of the dam, a stable run/riffle area was identified (see Figure 3). This reach will serve as the downstream limit of the longitudinal profile and as one of the 6 – 12 cross sections to be established and surveyed.
